Machine Type	Autocreaser Pro 50
Subject	Missing Creases and erratic operation.

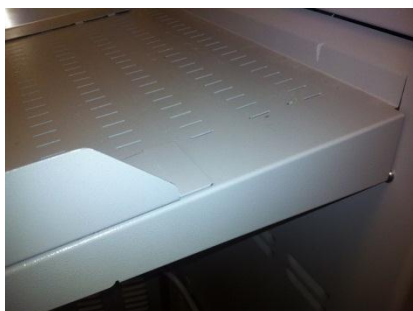
Tray fitted

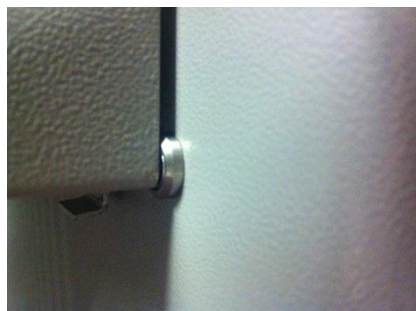
We have traced this static build up to poor connection of the earthing of the Stacker Tray on the output of the machine. The continuity of the earth should be through the Tray and the two buttons affixed to the main frame and can be checked using a resistance meter measuring from tray to frame.

Contact Points (both sides)

If there is a gap between the buttons on the frame and the Stacker Tray then a M4 flat washer should be placed beneath the buttons until continuity is measured.
